Understanding Ospringe

Report for the Bier House examination and associated excavations Open Area OA65 and keyhole pit KP66

**The Bier House of the Church of St. Peter and St Paul
Water Lane, Ospringe, Faversham.**

Grid Reference TR 00107 60301

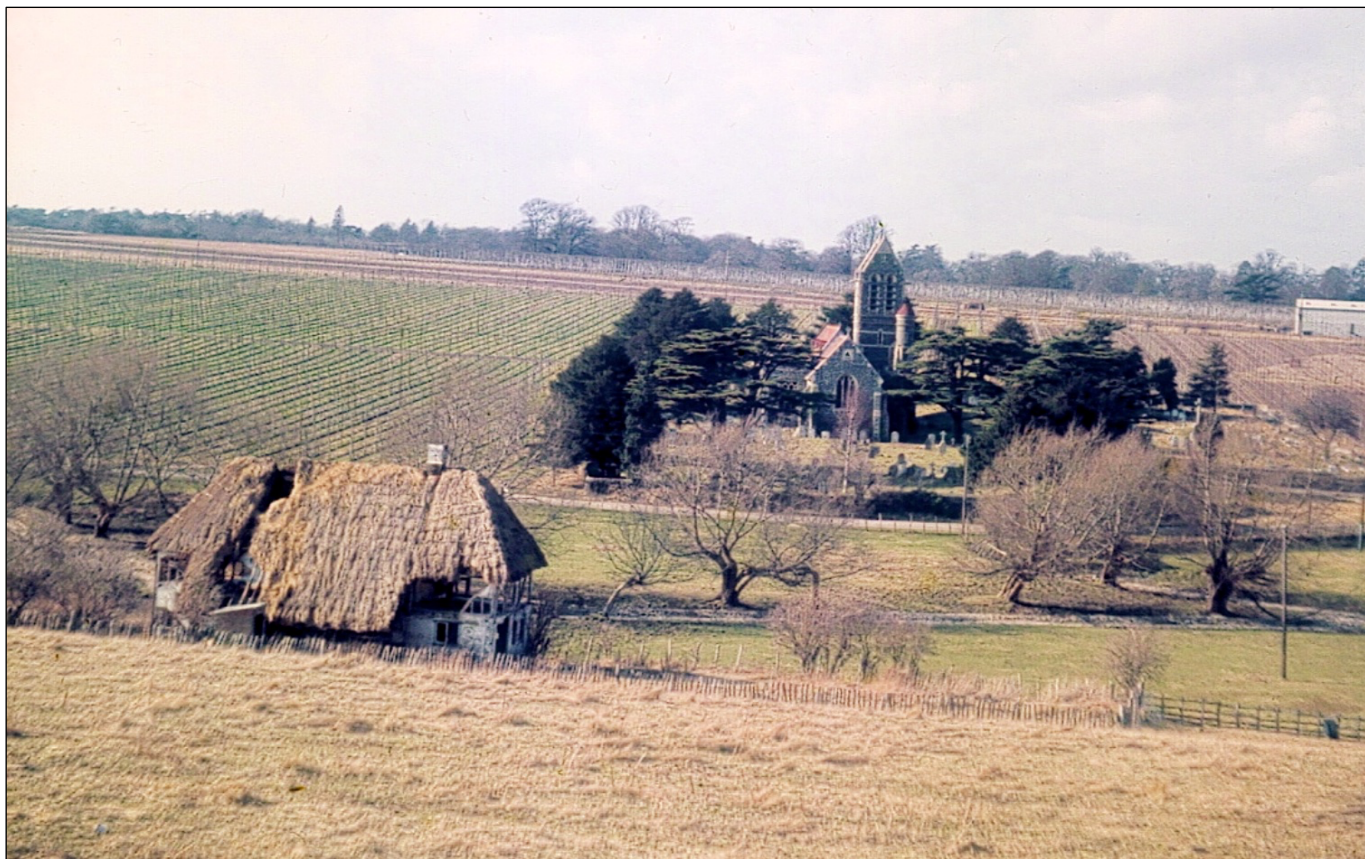
Fig 4: The middle Westbrook valley looking westwards. This photograph is the property of Arthur Percival and reproduced with his permission.

At the time of writing, but not available at the time of excavation is the interesting scene shown in **Fig 4**, looking westwards across the valley. This view dates from the 1950s and shows Brook Cottages just before demolition in the foreground. Although mostly hidden by willows, the Bier House stream seems broad and very shallow. This knowledge has been useful in interpreting the findings.

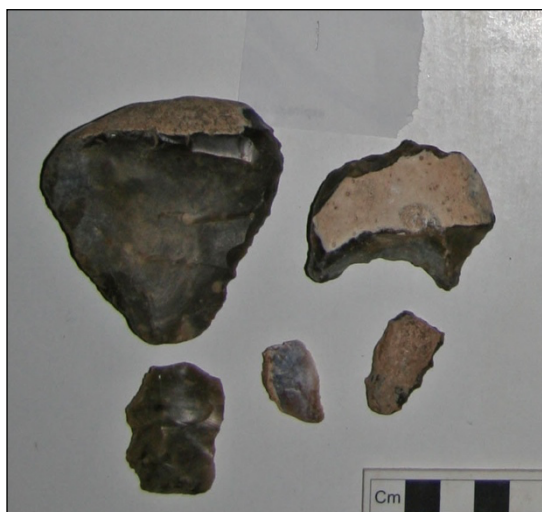
Fig 6: Flints from context 01. Pleistocene large flint pebbles modified in the Bronze Age.

On top of [03] the area was covered by a matrix of similar brown soil but with a much higher flint content, consisting of larger flints of between 5cm and 10cm in length [01]. These separate but similar contexts represent the field levelling and agriculture activities of the 1970s. They seem to show the initial activity moved the top soil from the neighbouring area into the pond / stream as [03] followed by [01] which was probably initially a neighbouring underlying context. This would explain the larger flints and the presence of a number of worked flints in this now surface layer.

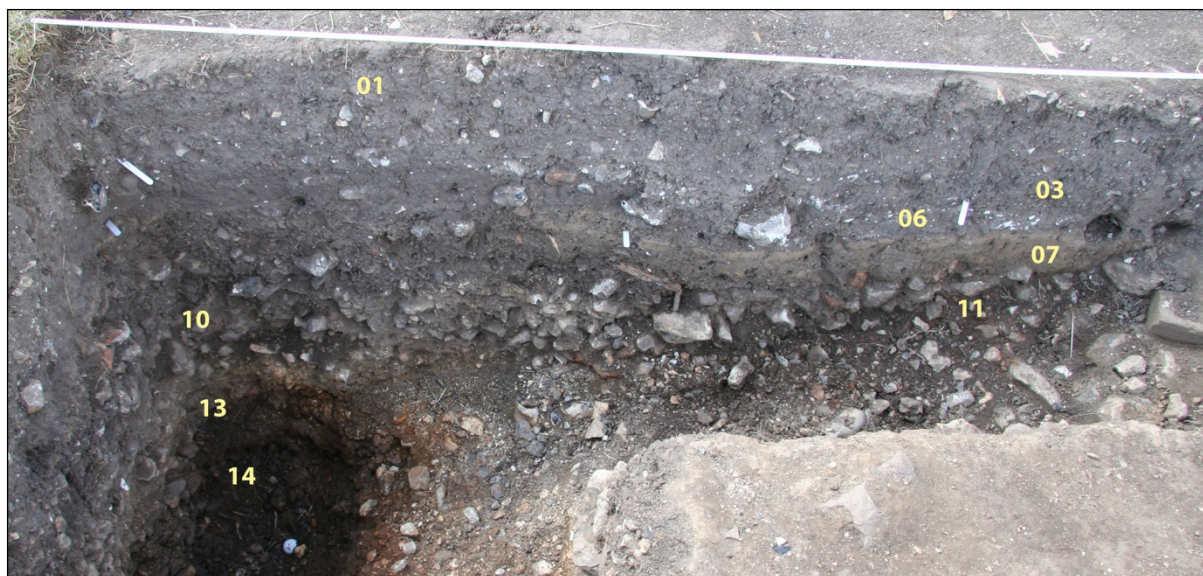
Fig 7a: Western baulk of OA65, southern section, with context labels.

The lowest level excavated was in KP65S where context [14] consisted of blackened large flints giving way to rust reddened large flints in [13] above it. The lower large stained flints and the gravels on top of them are the basal geology of the spring / stream / pond system at this Bier House location. The geology has an iron content and the anaerobic conditions at the lower level gives the flints the black (ferrous) iron oxide colouration and the more aerated upper layer the rust red (ferric). The gravel and sand of context [11] was on, not within, the lower flint matrix. Its upper part was however mixed with building brick-rubble, tile fragments and medium sized flints as context [10].

It seems that [10] was a rubbish dump in the pond / stream or is the edge of the banking of the stream / pond itself, with separate events dumping material onto it. This mixed zone continued to the north where it thinned to become the underlying sand of [11]. During excavation, it was decided that contexts [10] and [11] were evidence of the same dumping of building waste and the contexts were merged.

All of the above excavation took place in KP65S a keyhole pit 1m by 1m positioned at the southern end of the open area OA65. Above context [10] was a fine yellow-brown clay layer [07]. Although it was under 0.5cm thinning to nothing in the south, it thickened to the north of the OA65 excavation before thinning again 7.1m away at the northern end where another area of dumped building material rose through it, [09]. The surface of [07] was well defined and very level at 10.5m OD and at an average depth from the surface of 45cm. The clay may have been deposited out of solution as a sediment layer following a hill-wash storm event filling the pond. The surface of this fine clay had animal tracks indented into its surface indicating that it was either the lower surface of a shallow pond or the evaporative remains of one. The rats, or maybe water voles, had been tracking across this from the bank area at the base of the Bier House.

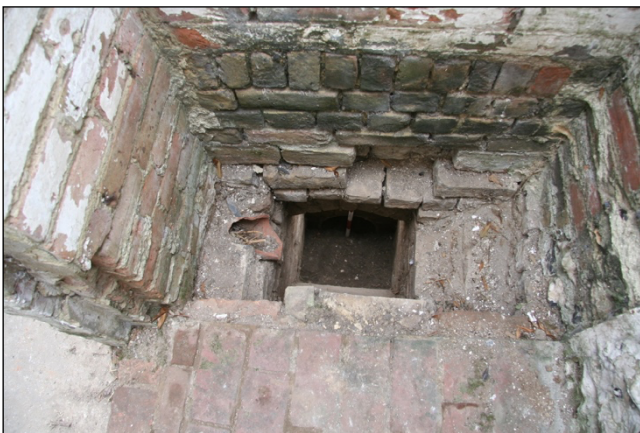
Fig 9: WC with excavated culvert.

At the rear of the building is a toilet area and we found this in a poor state as a result of minor vandalism. The small open enclosure consists of a urinal wall with drain gully to the north and a water closet (WC) to the south. This drain ran through the wall and it was assumed that both areas discharged into the cesspit, now filled in with rubble, found outside the north east corner of the building. The door of the WC area was missing although a rotting door post was present. There was no sign of a toilet bowl but the floor of the eastern end of this closet, where it would have been, had broken slabs of 2cm and 1cm thick slate covering an earth and debris surface. Markings on the walls clearly indicated that the slate formed the structure of a box for the seating. Removal of the top of the earth revealed a broken drain pipe heading towards the cesspit. On examination of the outside of the building, as the nettles and shrubbery were removed, an arch had been revealed in the brickwork at ground level at the rear of this closet area. The outside and inside of this area were excavated but not the cesspit itself.

The arched brick work was examined and the ground beneath it removed to reveal the lower section of wall to have been open but seemingly later almost bricked up, leaving a small gap at the top. This meant that the area under the seat had been an open drop with the possibility that the drainpipe was a later

The WC arrangements at the rear of the Bier House do have a bearing on the interpretation of some of the excavation findings in OA65. The discovery of the drainage system under the WC area and the wastepipe system to the cesspit does indicate the probability of a change of design at some point. The presence of building material dumped into the stream area could be linked to that change.

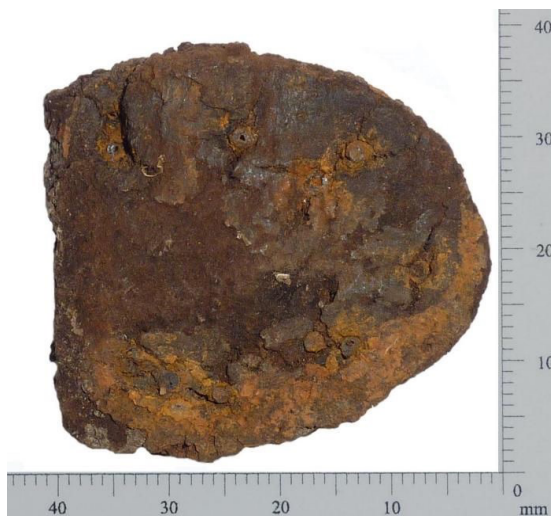
SF104

SF104: The heel of a shoe, probably from a child's shoe. There are tacks and tack holes, which are corroded. There are rust traces of a metal stake. The heel is made of two layers of leather which has a layer of rust between them.
