The Davington Mysteries 2010

Report for archaeological investigations K74, K76a, 76b, 76c, 76d.
7, 8 and 9 Stephens Close, Davington, Faversham, Kent

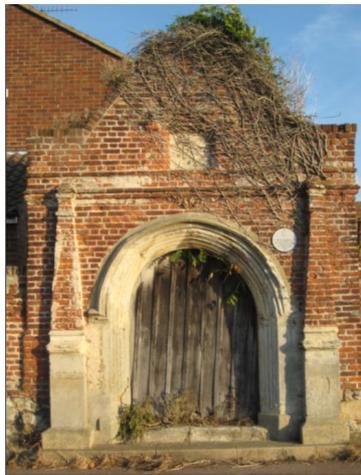
Fig 3: The Mannerist Gateway dated to 1624.

Numbers 9 to 12 of Stephens Close are bordered by walls of 17th century brick, lying on a 1m high base of re-used medieval worked stone and flint. This stone is mostly Kentish Ragstone but also contains at least one example of moulded Caen stone. An elaborate gateway in the Mannerist style with a plaque stating year of building as 1624 survives in the western wall, facing onto Oldgate Road (**Fig 3**). Another

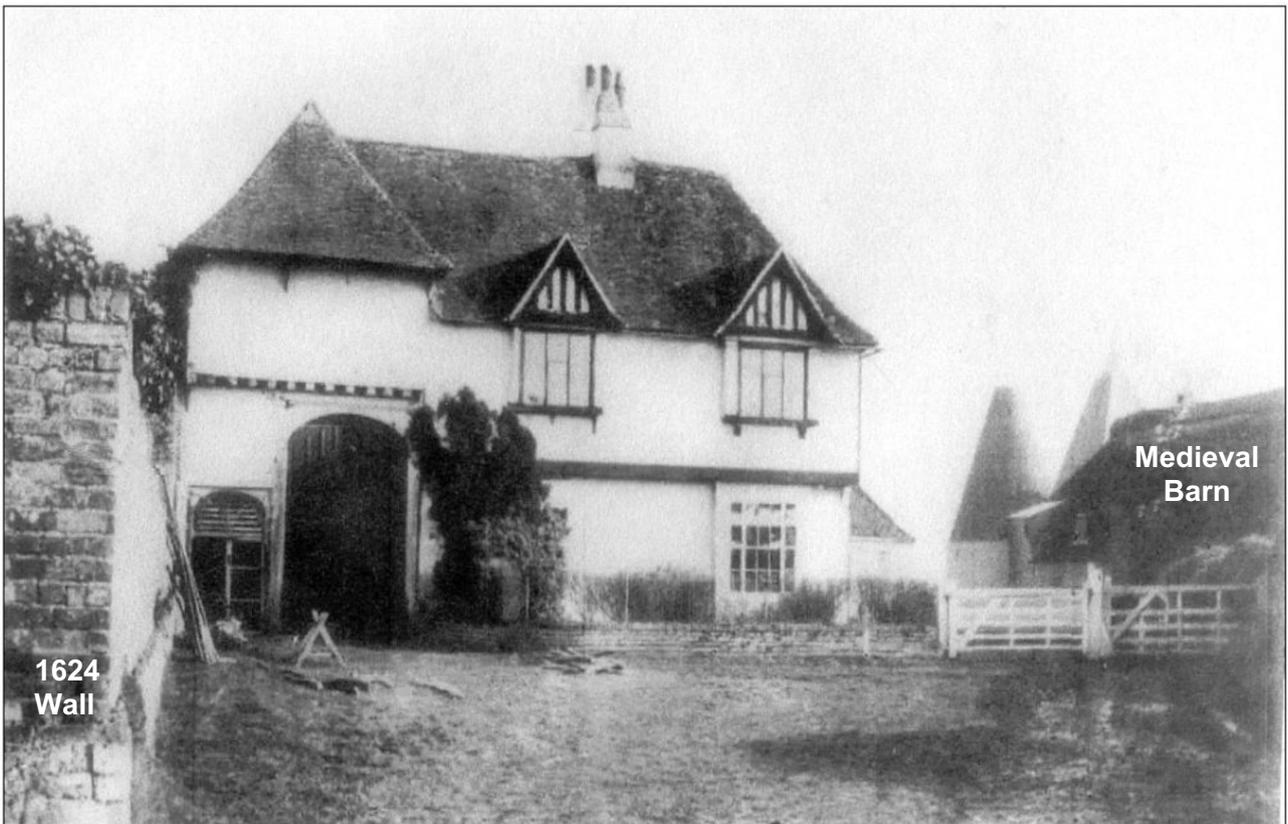
Fig 6: 'Davington Court' around 1880.

References to this 'ruin' can be found in several 19th century documents such as that of Crowe⁶ and Willement⁷, who describe a room-like structure overlooking Dark Hill in 1844. These documentary references and earlier ones make it clear that the so-called Davington Court (outside the 1624 wall) was no more than a dressed-up farm bailiffs house, and photographs from around 1890 and 1900 show this 'social mobility' dramatically around 1900 (Figs 6 and 7). Yet earlier documentary information indicates that there was indeed a 'Davington Court' or Manor here throughout the medieval period⁸, and the surviving stretch of medieval wall seems to be a part of this earlier and important building. This manor house, on documentary evidence, seems to have been abandoned around 1650-1660⁹ possibly because of the rapid growth of the nearby gunpowder industry in the Westbrook Valley with all of its environmentally invasive implications.¹⁰

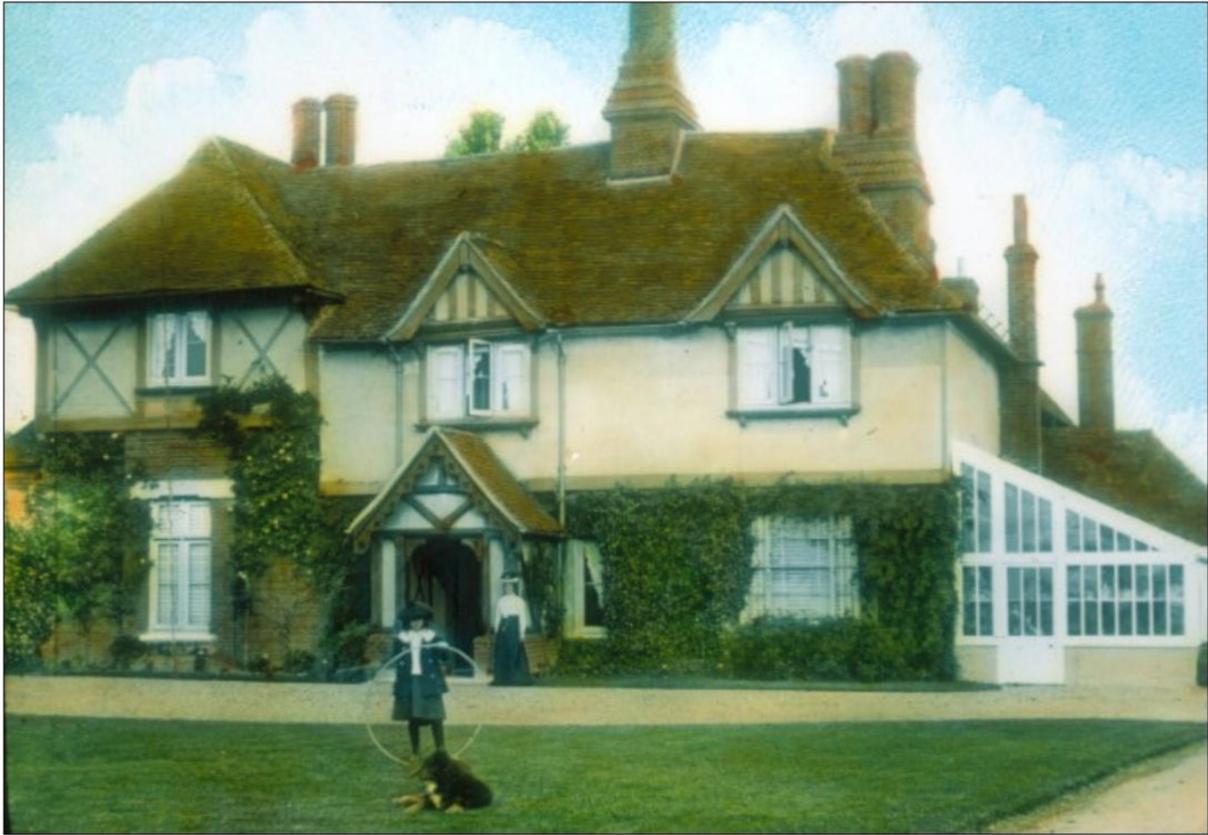
Fig 7: Davington Court around 1900 after 'renovation'.

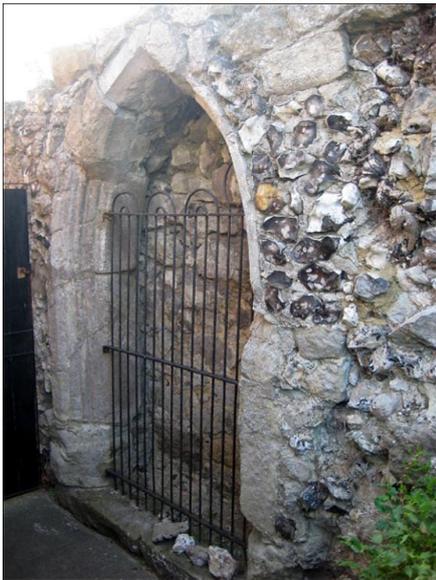
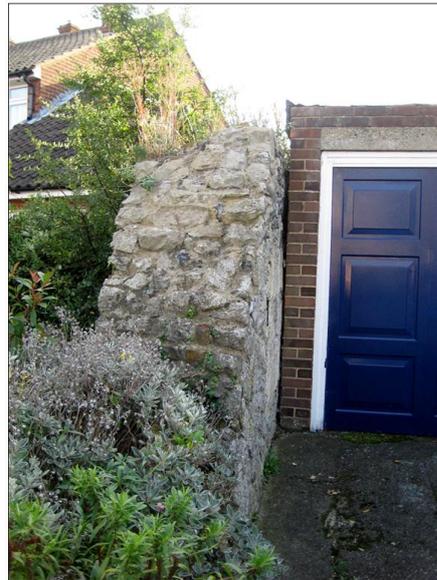
Fig 8: The medieval wall.

Above, the 13th century gateway and the northern (street) end of the wall. This end has been drastically restored but the massive construction can clearly be seen.

Even more striking is the survival between numbers 8 and 9 of a 17m stretch of medieval wall (**Fig 2**), including a 13th century gateway. The wall has an average height of 2m and a maximum height at the southern end of 5m. The northern and southern ends of the wall show signs of major reconstruction but the middle section is composed of well-shaped, neatly coursed medieval stonework. At the southern end, the wall makes a right-handed turn, as for a room corner. Exposed sections of the end wall show a rubble filling and abundant mortar containing large shell fragments.

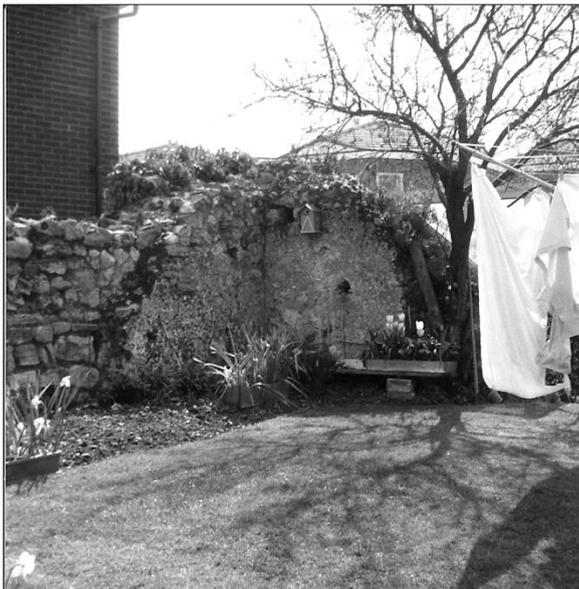
To the left, a 1960s picture of the south end of the wall, showing the corner with as-yet undated plaster covering.

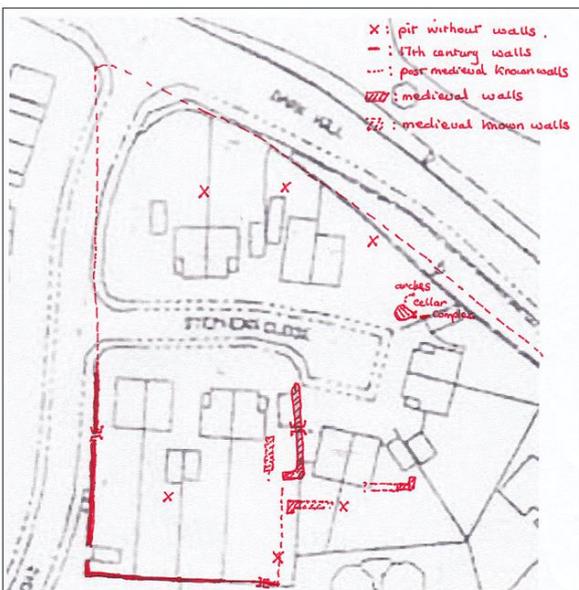
Left below, a map showing the known walls in the study area, after the 2010 FSARG season.

Much more useful was information from householders. Dave of No. 9 told us that when the extension to No. 9 was built around 2006, a length of flint and stone wall was exposed. This now lies underneath the extension (see **Fig 8** map). No. 8 has a much smaller garden, carefully cultivated, and Brian the householder told us that he was convinced that a wall crossed his garden running north-south about halfway down the garden. He had also had glimpses of a flint wall when putting in the fence separating Nos. 8 and 9. In addition, study of early maps (**Fig 4**) showed that the 17th century wall encircling this area had previously extended through the garden of No. 9: nowadays it only survives as a stretch along the back with a Mannerist gateway still existing (**Fig 3**).

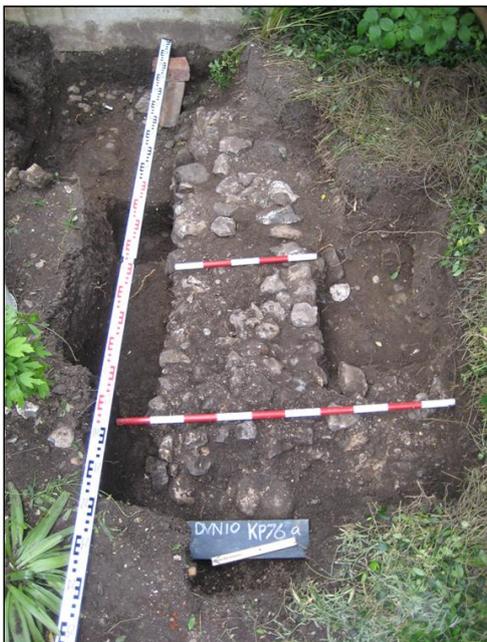
Fig 9: Flint foundations, with neatened edges.

The lowest deposit exposed [6] was a greyish-green shingle, pebble and sand deposit at a depth of 50 cm. This was free of any kind of artefacts and seen as Thanet Beds, the natural deposit. Lying over this was a yellow brown clay deposit [5] with specks of shell, brick and tile at its upper level but at its base completely free of inclusions apart from occasional small rounded flint pebbles. [5] contained a few tiny sherds of prehistoric pottery. Set down into [5] was the corner of a flint-built structure [4] (see **Fig 9**). The outer flints were neatly trimmed to give a straight edge line with the inner filling flint and mortar rubble. The flints were held together with lime mortar containing large pieces of cockle shells and smaller complete shells. The flint walls were around 60cm in thickness, with the top surface around 30cm below modern ground level.

The flint walls found in 76a and the wall segment in 76c are different in character. The flint corner is shallow in depth and probably a foundation, possibly for a timber building with peg tiled roof. The surface, perhaps a courtyard or floor, abuts the flint wall foundation, which implies that it is

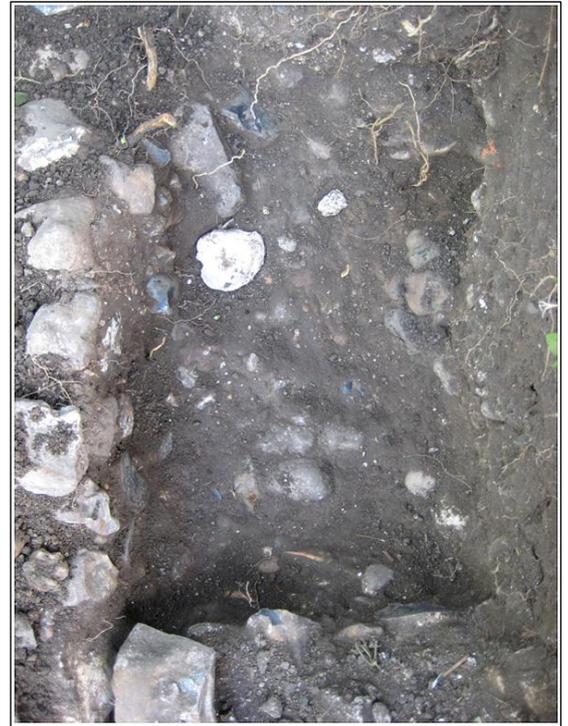
Fig 10: Close up of pebble surface with oyster shell.

Inside the corner, at a depth of 40cm (which corresponded to the top of the [5] level on the outside of the wall) was a surface made up of small evenly sized flint pebbles packed tightly [8] (see **Fig 10**). Resting on and embedded into this pebbled surface were animal bone fragments and a complete oyster shell.

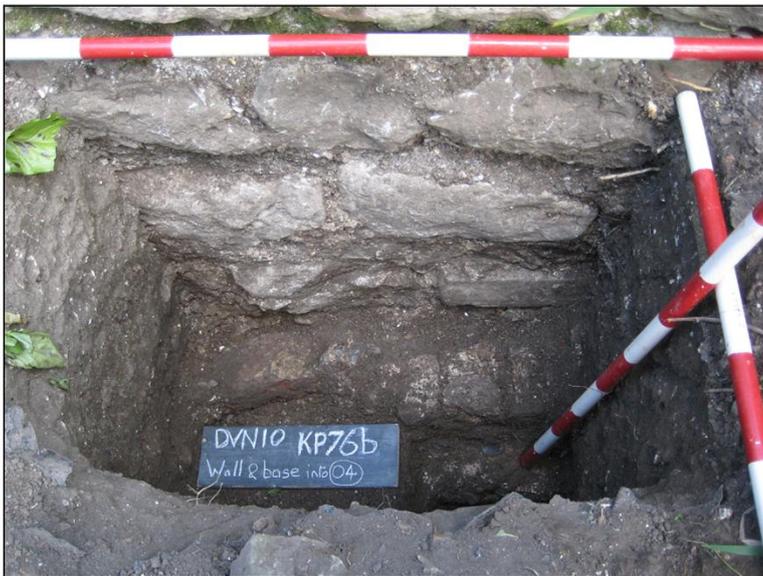
Fig 11: Wall base with ledges.

As can be seen in **Fig 11**, the stone blocks continue straight down for 70cm, and then two ledges were uncovered. The uppermost ledge contained a 17th- 18th century red brick, a possible repair.

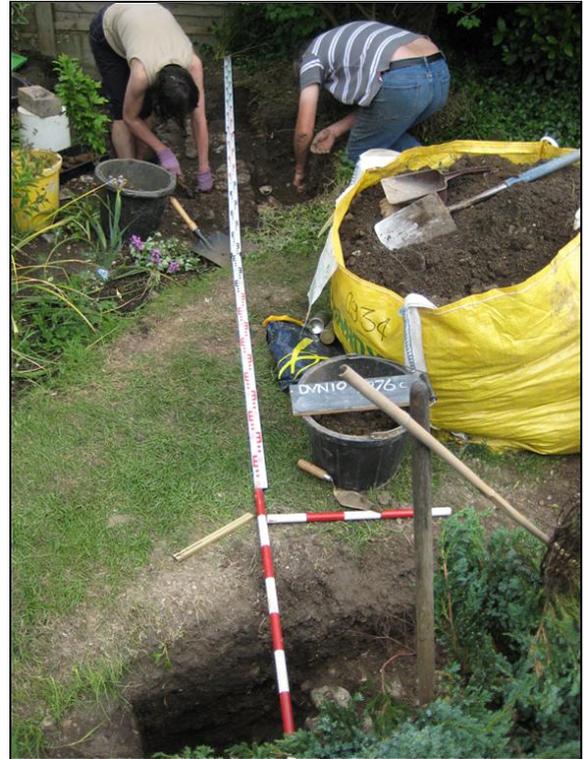
In Fig 12, 76a is being dug in the background, with a long measure running along the east-west flint wall in 76a. An east-west wall is visible in K76c in the foreground, and is shown in more detail in Fig 13.

Fig 12: The relationship of K76c and 76a.

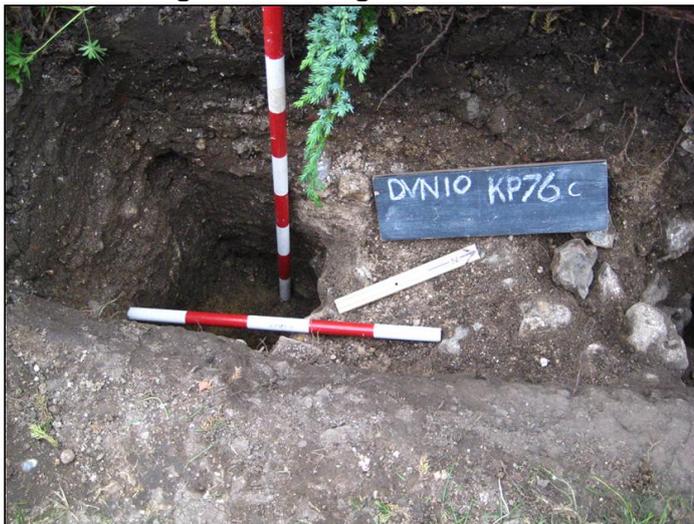
Fig 13: Wall segment in K76c.

This wall was made up of flint, stone and a finer lime mortar than that used for the walls in 76a. Although seeming to have the same orientation as the main wall in 76a, it was slightly further south. The wall also extended much deeper than the one in 76a, into a yellow brown deposit, uncovered at a depth of around 65cm. South of the wall was a thick deposit of mortar and other building material. In this trench, the wall was 65cm - 70cm wide.

earlier than the foundation and cut by it.¹⁶ The wall section in 76c goes much deeper and has a stone content, which hints at it being associated with a different building to that exposed in 76a. What does seem clear is that both walls are at least late medieval, possibly early post medieval (i.e. from around AD1450 to 1600) and therefore associated with the demolished manor building. K74 showed clearly that the flint foundation building did not extend into the garden area of No. 7.

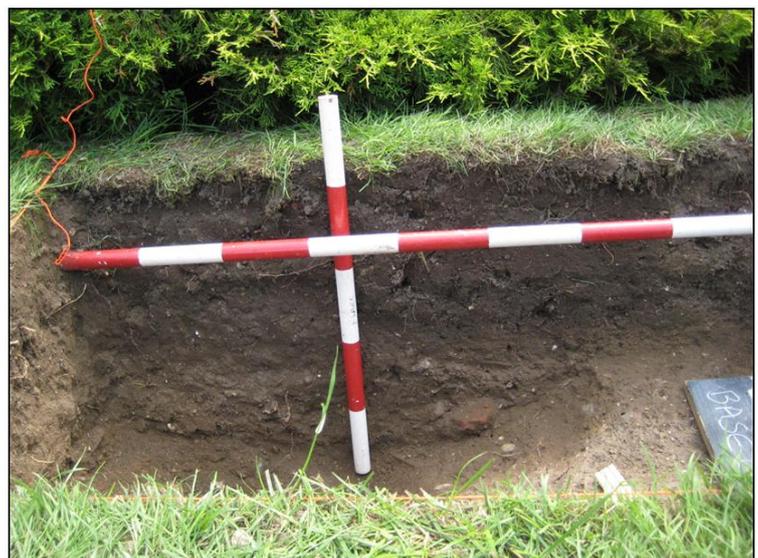
Under the turf [1] was a dark brown friable layer of garden soil [2], overlying a yellow - brown more compact sub soil [3]. The base of [3] although parallel with ground level in the west of the trench dipped down quite suddenly at the mid point, rising again towards the east end. This dip [5] ran south north across the trench, and held a fill of building rubble and soil [4]. The rubble consisted of small fragments of peg tile, lime mortar, ragstone, flint, chalk and some very small fragments of red

Fig 14: K76d fully excavated.

The absence of any signs of the 17th century wall in 76d was unexpected, unless the shallow dip with rubble was the result of a clumsy digging out of the wall foundations, destroying any kind of foundation trench.

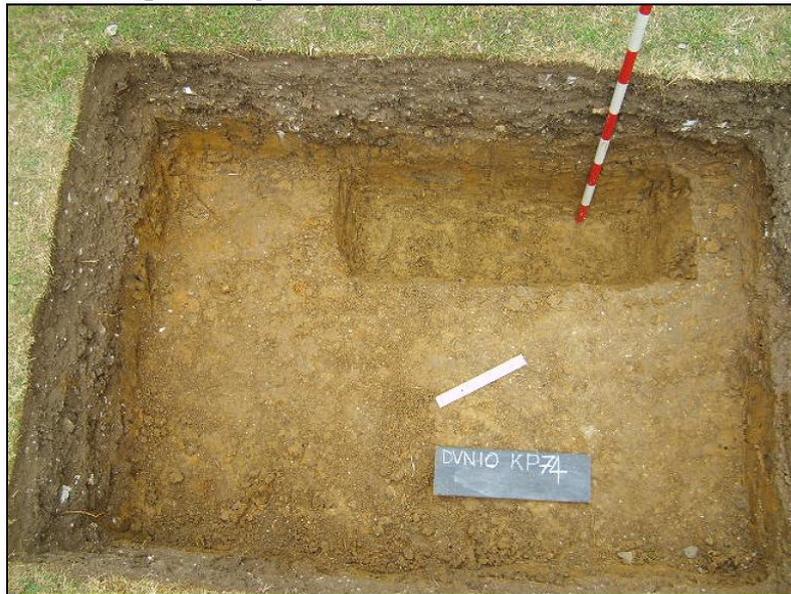
Fig 15: Keyhole 74 at end of excavation.

K74, however, produced only negative evidence. Beneath the turf [1] was a layer of dry, friable brown soil [2] with many small inclusions such as chalk, tile, and a few small flints with mortar. Two residual Mesolithic blades were found, along with a few pot boilers. Below [2], however, was a layer of dense yellow brick earth [3]. This was dug to a depth of 65cm and had no artefactual content whatsoever, let alone a wall foundation.

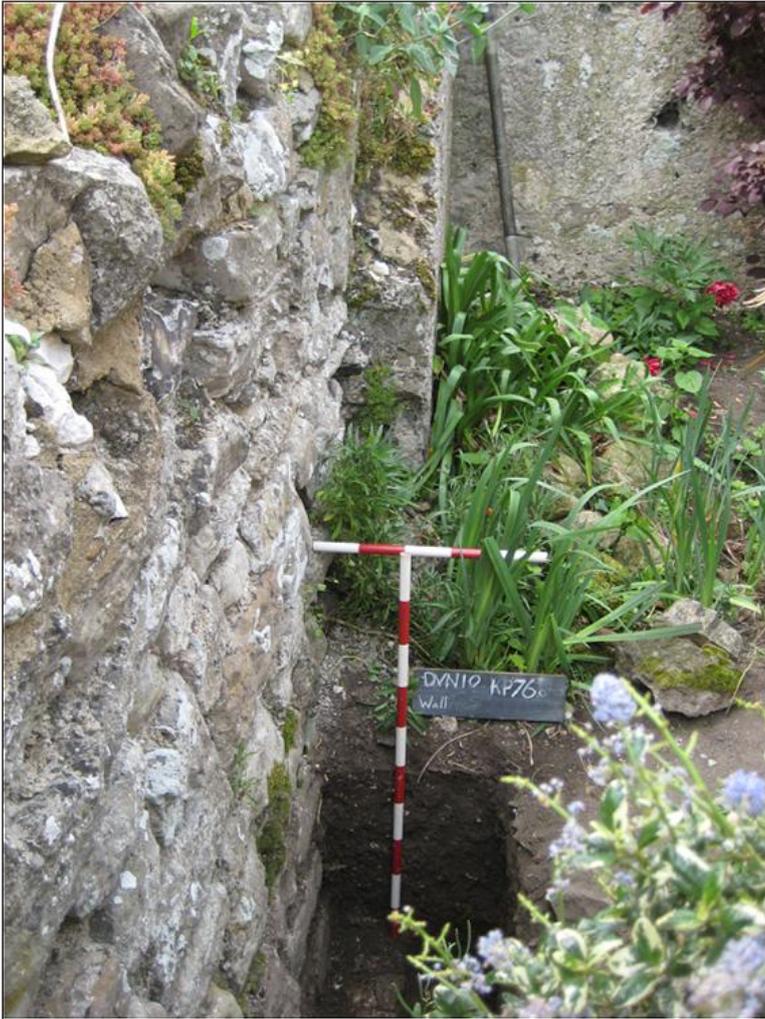
First of all, the standing wall: this was shown to extend down for a considerable depth below the present ground level. The slot K76b did, however, show a ledge like structure at the base of the wall. This contained a post medieval red brick, suggesting repair at the post medieval stage. In **Fig 16**, the ledge can clearly be seen at the base of the slot and in the background and just beyond the slot can be seen a thickening of the standing wall which does seem to line up with the top ledge width. It has been suggested that this is part of a stairway. Right at the back can be seen the wall which forms a right angle to the main wall.

Fig 16: K76b with standing wall.
